Manhole Inspection Summary

Manhole # S2501_002MH

Insp Date: **3/5/08 8:46 AM**

Location Address: **1000 W Patapsco Ave**

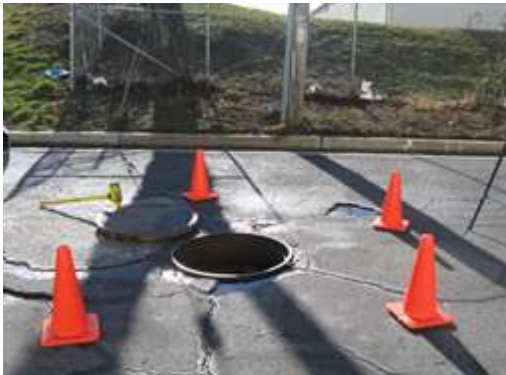
Location View

Viona Ave.

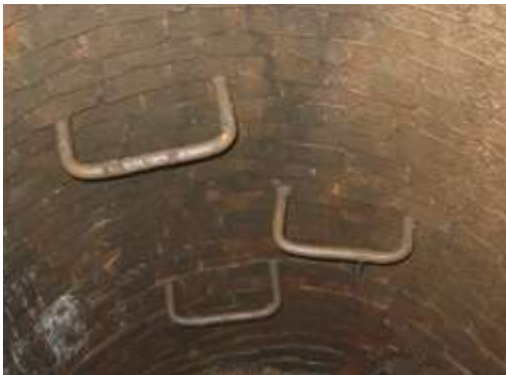
Steps

Count: **3** Missing: **0** ☐ Corroded

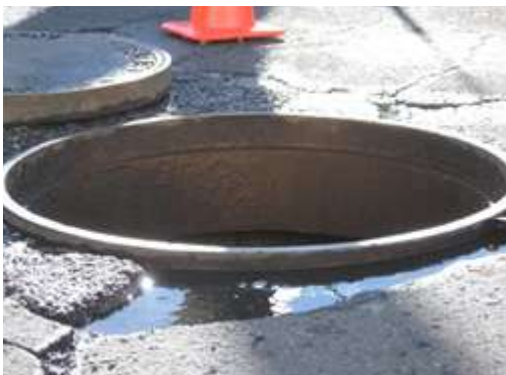
Defect 2

Above grade

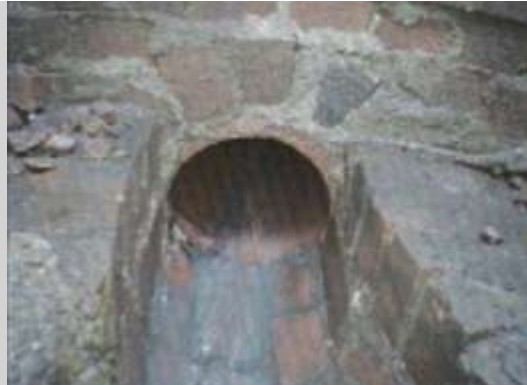
12 O'Clock Outflow

8 in. Circular Gravity Sewer
Pipe Out @ 12 O'Clock

Pipe Height: **9.6** (in.) Rod and Bar (Angled)
Pipe Material: **Clay** ☐ Pipe Lined
Invert Depth: **8.28** (ft.) Flow Characteristics: **Fast**
Deposits: ☒ None ☐ Mud ☐ Sludge ☐ Debris ☐ Grease
Silt Depth: (in.) Deposits Extent:
Infiltration: **None** Pipe Seal Cond: **Sound**

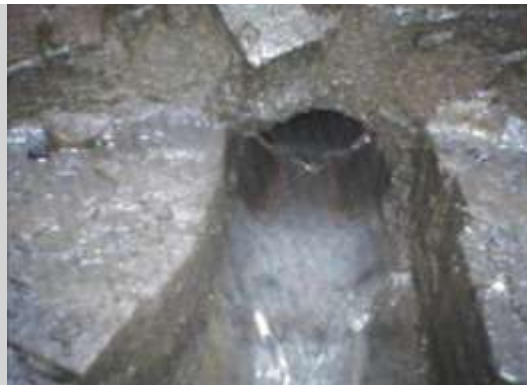
3 O'Clock Inflow

6 in. Circular Gravity Sewer
Pipe In @ 3 O'Clock

Pipe Height: **7.2** (in.) Rod and Bar (Angled)
Pipe Material: **Clay** ☐ Pipe Lined
Invert Depth: **7.89** (ft.) Flow Characteristics: **Fast**
Deposits: ☒ None ☐ Mud ☐ Sludge ☐ Debris ☐ Grease
Silt Depth: (in.) Deposits Extent:
Infiltration: **None** Pipe Seal Cond: **Sound**

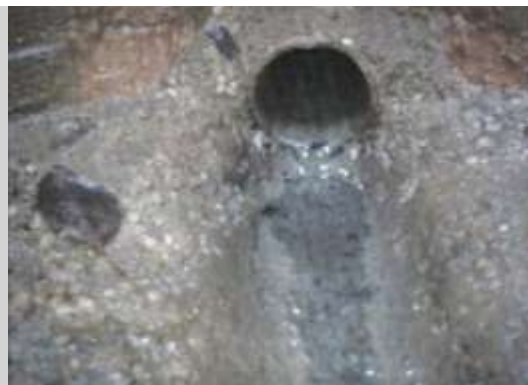
7 O'Clock Inflow

4 in. Circular Service Sewer
Pipe In @ 7 O'Clock

Infiltration: **None** Pipe Seal Cond: **Sound**
